## 5.2 Area B – Stockton

5.2.1 Area B forms the south-western part of the settlement and contains the historic core of the village and the renowned Stockton Bury Gardens. The area contains an important group of listed buildings and the valley of the Cogwell Brook which forms a key topographical feature of the village.

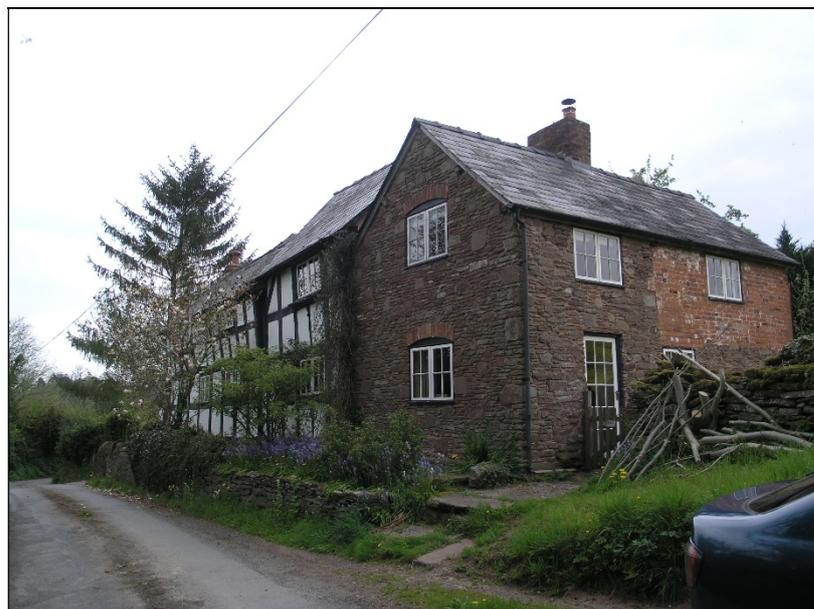
**Image 63 - The Old Workhouse**

5.2.18 Probably the oldest building in this part of the village is the Grade II listed **Old Workhouse**, being dated by the RCHME to probably early sixteenth century. Originally four properties, it now comprises a timber-framed part facing the lane and a stone extension, having some brick in it. This has the gable end in-line with the oldest, timber-framed part. Used in its construction are very substantial timbers, with in-filled jettying supporting a huge bresummer beam. Wattle and daub fill the spaces between the timbers. The windows' frames are of timber and its roofs clad in slates. In the timber-framed part, the ground floor gently leans inwards while the top leans outwards in a similar manner. A stepped stone chimney, topped in brick is at the gable end. At the property's boundary with the lane is a stone wall, linking all of the buildings together.

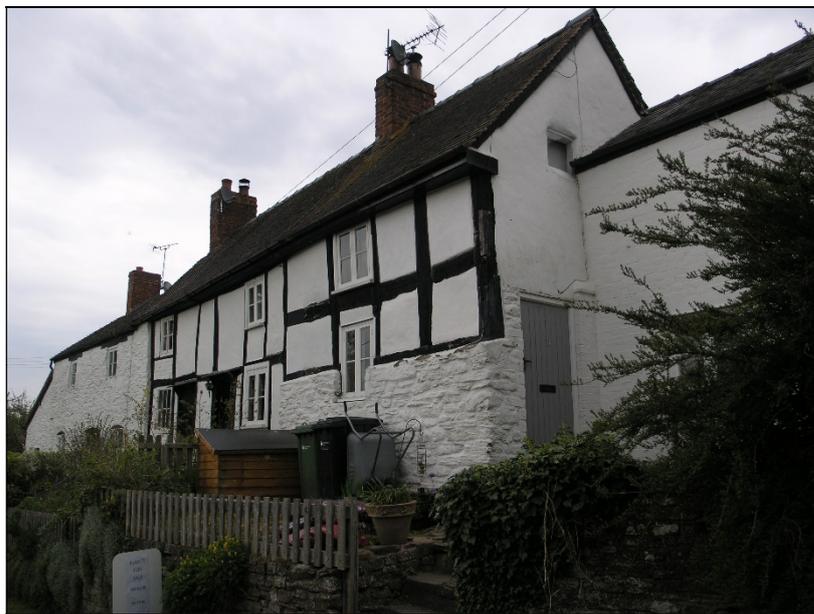
Image 64 - Stockton Terrace

5.2.19 Around a very sharp corner, on the same side of the lane, is a row of eighteenth century terraced cottages, formerly homes for employees on the farm. Furthest away from the Old Workhouse the cottage is painted white, covering the stone from which it is built. This is the largest in the terrace. Next to it are three much smaller, timber-framed cottages, two having their front doors very close together. Wattle and daub infill is over much of these buildings, although a small part has been replaced with brick. Clay tiles are used for the roofing. As for the Old Workhouse, **Stockton Terrace** has a stone wall which unifies the whole – but this time, it is topped by a picket fence.

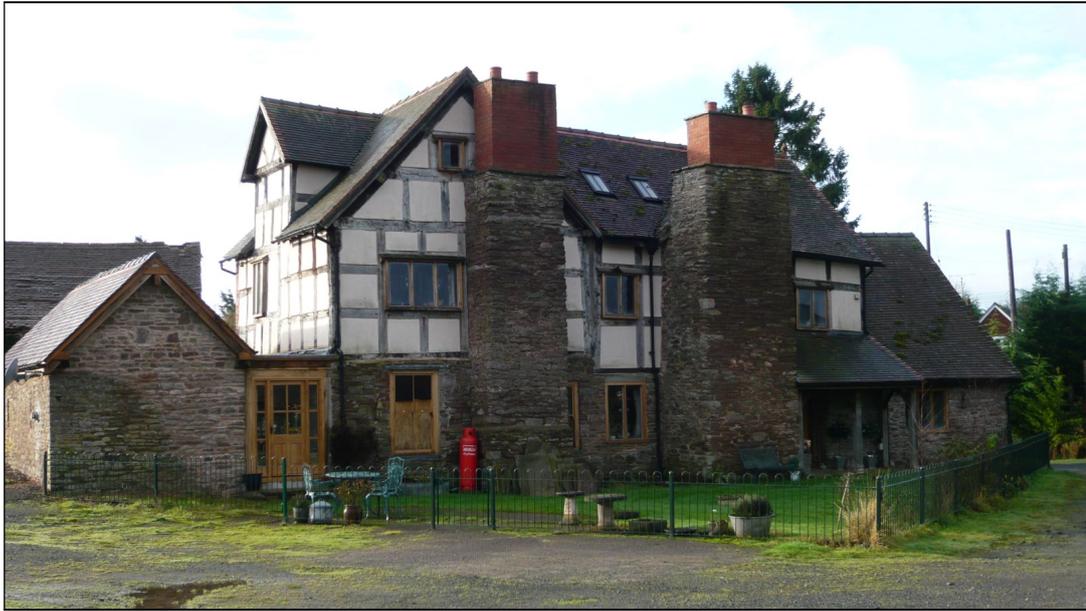
Image 65 - Brook House Farm showing the massive chimney stacks

- 5.2.20 Set well back from the lane is the Grade II listed **Brook House Farm**, another old, timber-framed and stone building, probably dating from the seventeenth century. Set in a valley, the house has the brook running by the side of it and on the opposite side, there is a quite steep grassy bank. Surrounding the front and the left-hand side of the property is a stone wall.

- 5.2.21 The old farmhouse is mainly built of stone on the ground floor and a mixture of stone or timber-framing on the first. The front of the building has much more timber framing with some stone at the base and to the gable which is mainly brick. At the back are two huge, straight stone chimneys; one being larger than the other. It has been joined to the house by stone infilling. The stacks at the top of each chimney are made from brick. The roofing material is clay tiles.

- 5.2.22 On the right-hand side of the house are several old stone barns, sometimes having timber-framing and brick infill, or feather-edge boarding in the upper parts. One barn was a granary and still retains the fixtures for a pulley for a gib (though this is missing). Clay tiles roof these buildings. There are other platforms where barns once stood and on the brook bank are two large timber barns.

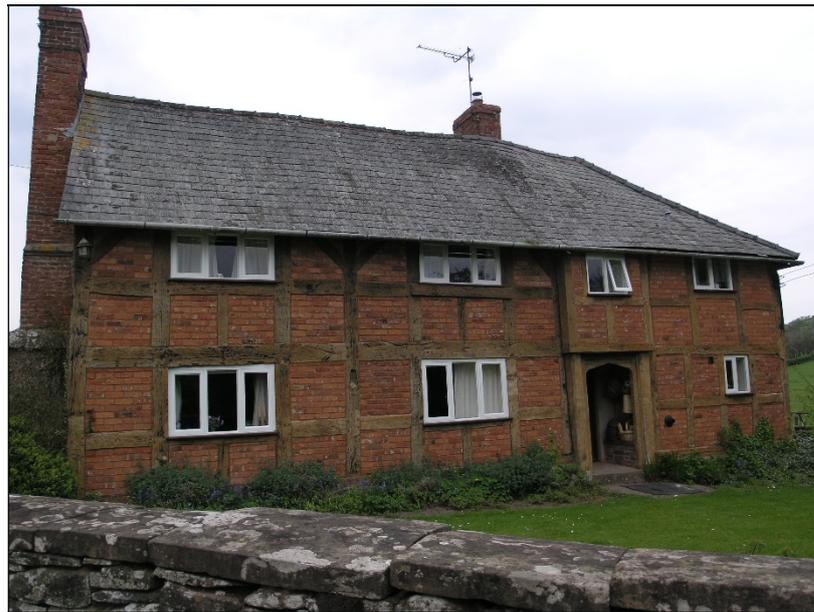
Image 66 - Lower Stockton

5.2.23 On the opposite side of the lane is the Grade II listed **Lower Stockton**, set back from the lane by a small front garden, a seventeenth century timber-framed building having brick infill throughout. Its timbers are substantial. The roof line suggests it was built in two stages because it dips at the right-hand end. This change in the roof is very apparent at the rear. On the opposite end gable is a large, stepped stone chimney, finished in brick at the top. The front wooden entrance porch and door are solid and decorative. Slates are used for the roof and timber for the windows. At the rear of the property flows the Cogwell Brook. A stone wall retains the bank the house sits on. Another stone wall curves gracefully around the front of the house.

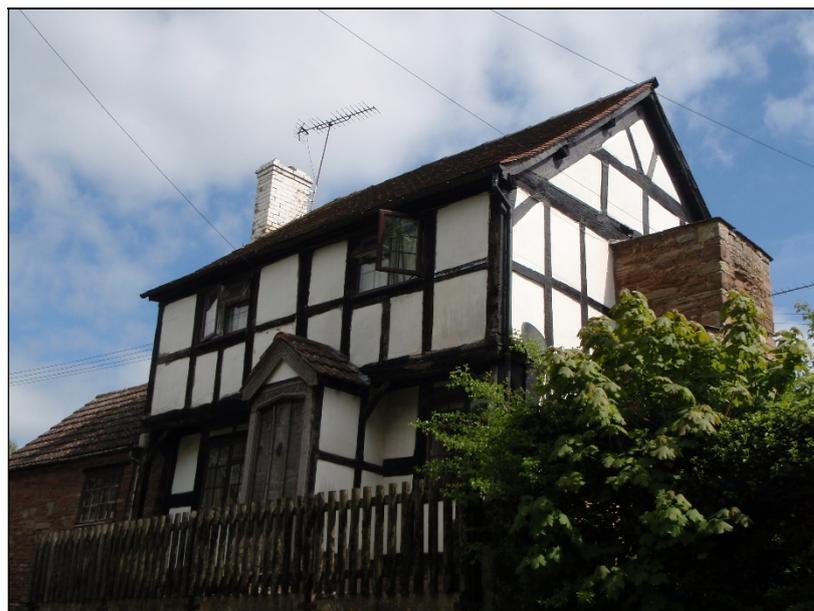
Image 67 - Moss Cottage

5.2.24 Further up the lane towards the crossroads is the Grade II listed **Moss Cottage**, probably built in the sixteenth century (RCHME) and situated very close to the lane. It has

exposed jettying, an oak front door and attractive carved details on the porch which has two stone steps at its base. The cottage is built of timber, wattle and daub, with a stone extension at the end nearest the crossroads. The base is built of stone and the roof truss at the gable end rests on it. From the truss to the roof ridge beam is timber framing. The chimney at this end is made of brick while that at the other end is a huge, stone one. Clay tiles roof the property. A picket fence sits on top of a concrete base.

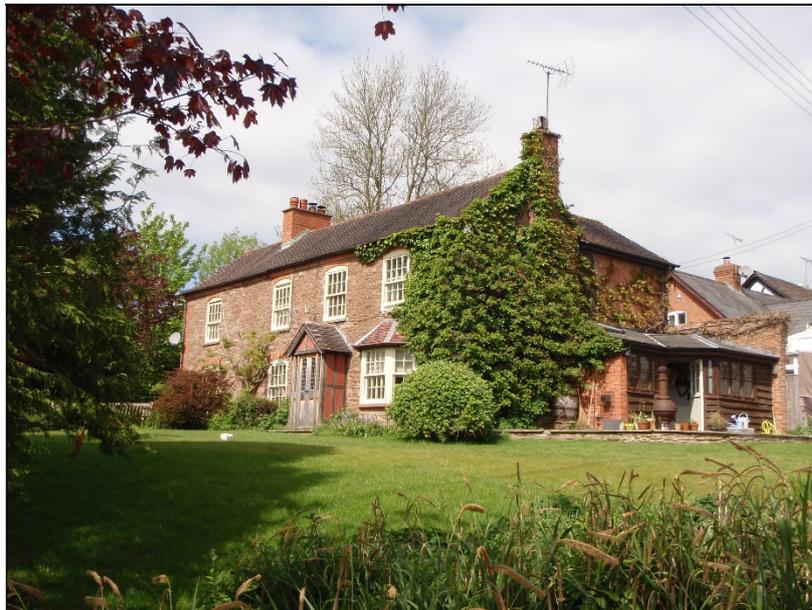
Image 68 - Hawkesbury

5.2.27 On the other side of the yard entrance is **Hawkesbury** and, like Ballard's cottage, presents its (brick built) gable to the lane. Its front is an imposing, possibly eighteenth century, four-bayed, stone built house. It has decorative brick detailing to the windows and under the roof. A bay window is on the ground floor and there is a later porch. At the rear, the ground floor is mainly of stone, brick for the upper, possibly being an extension to an original single storey building. The roof here has three gables. The whole building is roofed in clay tiles.

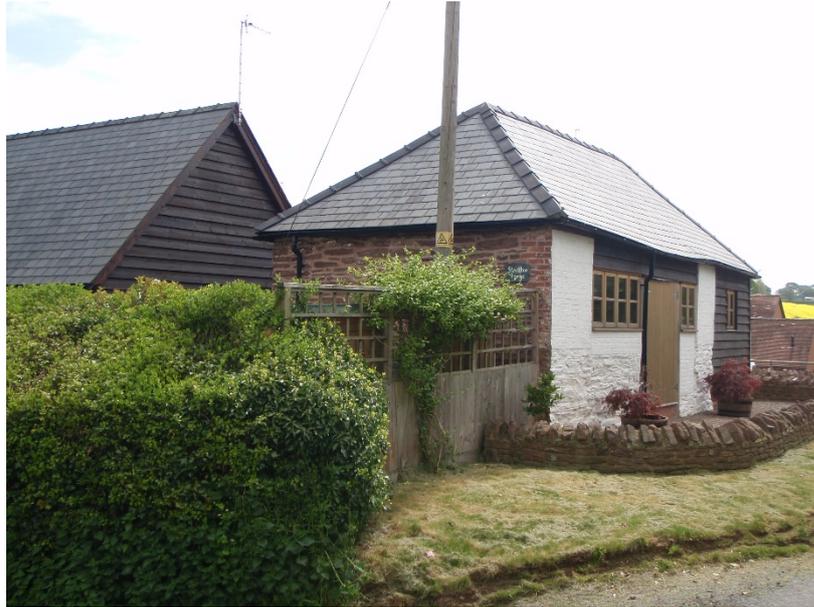
Image 69 - Stockton Forge

5.2.28 Where the lane meets the main A4112 road is the site of the old smithy, now known as Stockton Forge. This is a modern building blending in sympathetically with the other old buildings in the lane. The string course suggests there could be timber hidden beneath the house's rendering. Either modern handmade, or reclaimed clay tiles have been arranged in a rhythmic pattern of two different muted colours. A stepped stone chimney finished in brick echoes ones found in older properties in the lane. Timber cladding on the single storey relates well to that on the original, Old Forge building which has been sympathetically restored. Tucked away unobtrusively behind the Old Forge is a modern garage.

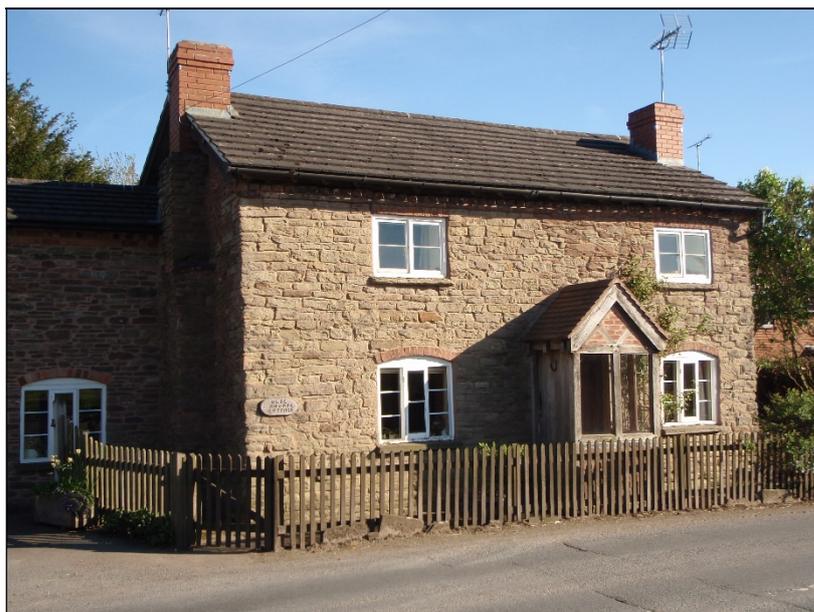
Image 70 - Old Shoppe Cottage

5.2.29 **Old Shoppe Cottage** is found on the main road. Built of stone, it has brick detailing over its windows and below the roof, with decorative bargeboards that are probably not

original. An extension to the side nearest the crossroads is sympathetic with the rest of the cottage. The whole building has been re-roofed fairly recently. A picket fence runs around the property which is right up to the road.

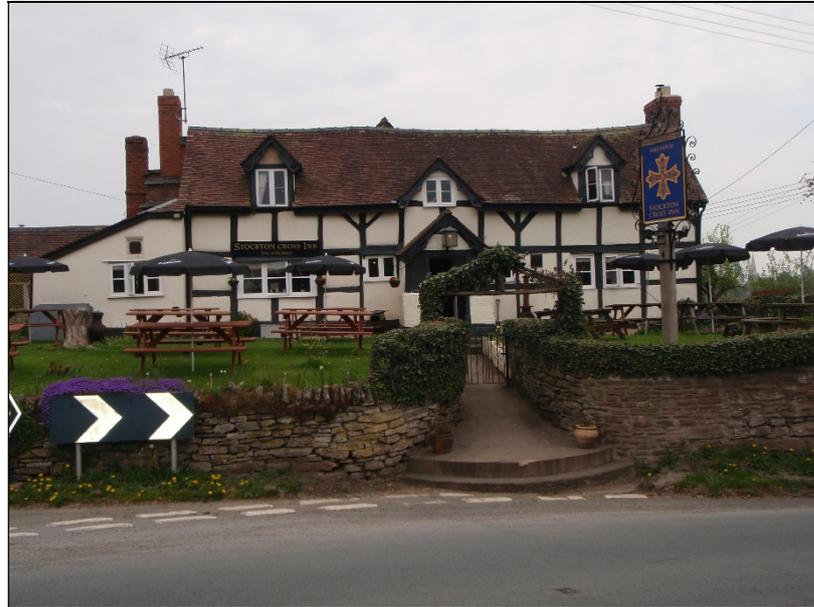
Image 71 - The Stockton Cross Inn

5.2.30 Also on the main road is the Grade II listed **Stockton Cross Inn**, a timber-framed, old drovers' inn, probably dating from the late sixteenth or early seventeenth century. It is situated on a bank at the crossroads of the village. At the front, it has three dormer windows, a large porch and a later extension which is rendered to the left-hand side. There is a stepped stone chimney topped in brick. To the side and slightly set back is another extension built of stone at the base, completed in brick on the upper part and the whole painted white. Decorative barge-boarding can be seen on the rear gable. Several old outbuildings/barns remain, some in poor condition; one built of stone and another mainly of brick with some timber framing. One has been restored fairly recently.

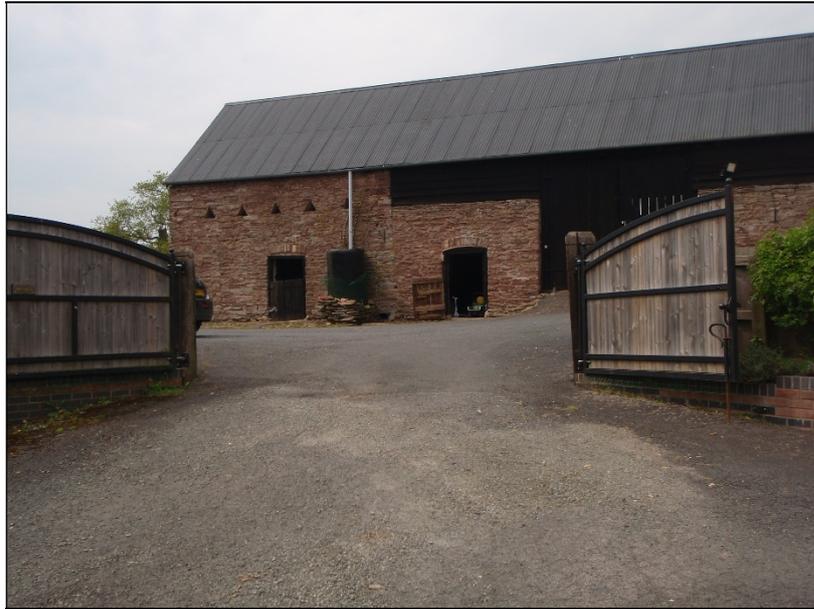
Image 72 - The Barns at Stockman's Cottage

- 5.2.32 Stockman's Cottage, a modern, two-storey house, has two old, stone-built barns. The one facing the lane has a corrugated steel roof. On its left-hand side are openings for ventilation on the upper storey while below and to one side of these are two stable doors for horses. In the middle are two large wooden doors. Mainly built of stone, there is some feather-edge boarding either side of the doors and under the roof. Running at right-angles to this is a stone, single storey barn. It has some wooden boarding either side of an open area. The property is enclosed by stone and brick walls, a wooden fence and two large gates.

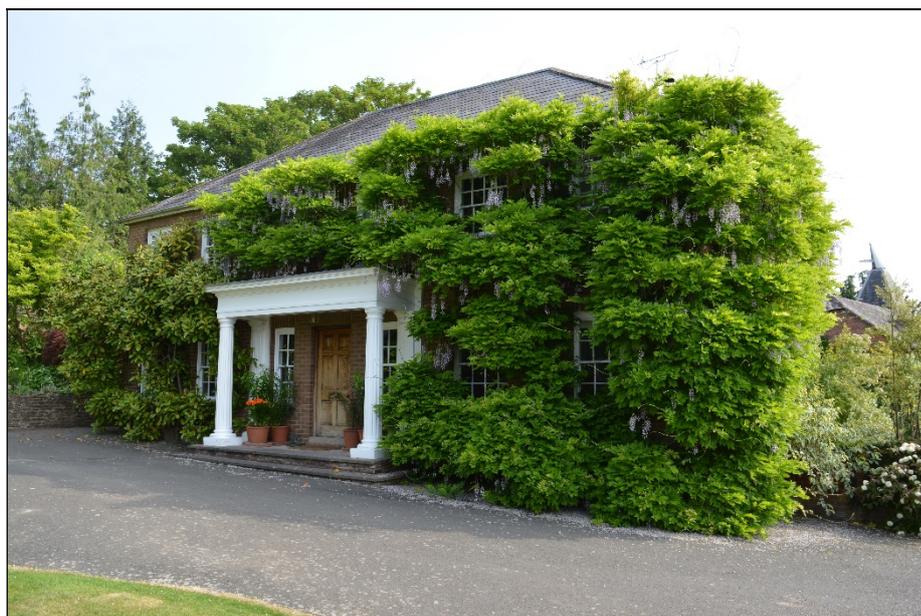
**Image 73 - The House, Stockton Bury**

5.2.36 The present house was built in the 1970s and stands on much of the original house platform. It has wooden window frames and front door. Classical-type pillars support on either side the entrance porch. Slates from the original house were used to roof it.

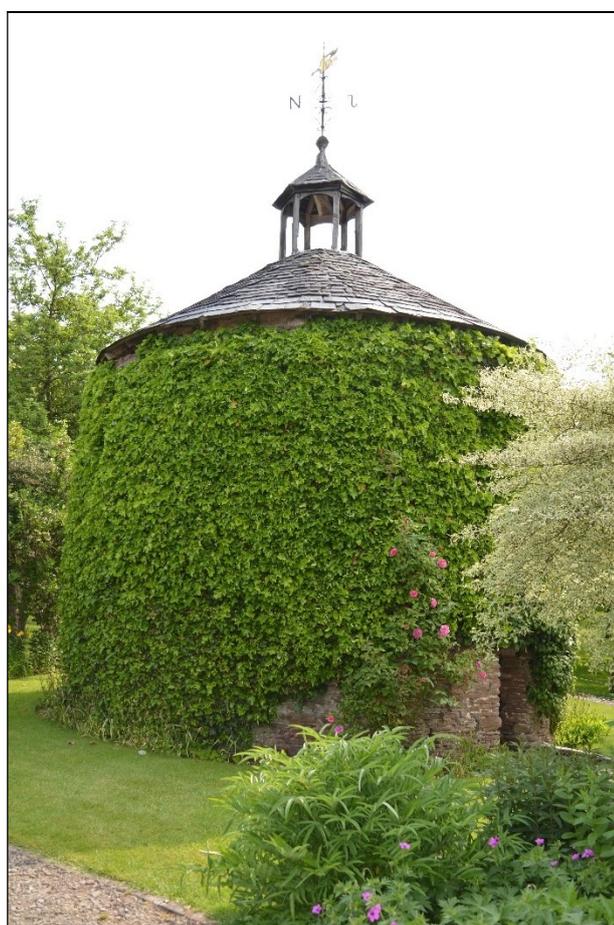
**Image 74 - The dovecote, Stockton Bury**

5.2.37 The dovecote, a listed building, is referred to in the lease of 1554 to Agnes Vale mentioned above. The building is circular, stone built with a conical slate roof. On the apex of the roof is a wooden lantern where originally the pigeons would enter and exit. At the top is a weather vane. Inside are the holes for pigeons' nests all around the wall and a wooden ladder to access the nests for eggs, though it is not original. RCHME dates the building as probably medieval.
